A V TECHNOLOGY LIMITED

Case History No.2 BALL BEARING INNER RACE DEFECT

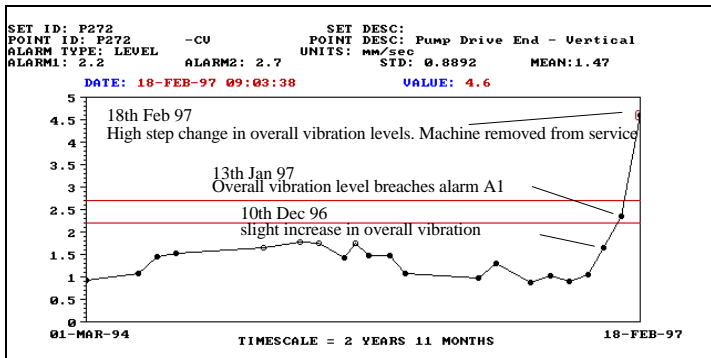
Vibration data collected from P272 motor and pump had over the last 32 months exhibited low and acceptable values, typically around 1.5 mm/s rms throughout. Vibration data collected in January 1997 indicated an upward trend at the pump drive end indicating a probable fault within the pump, see Figure 1 below.

Figure 1 - Continued increase of overall vibration levels at pump.

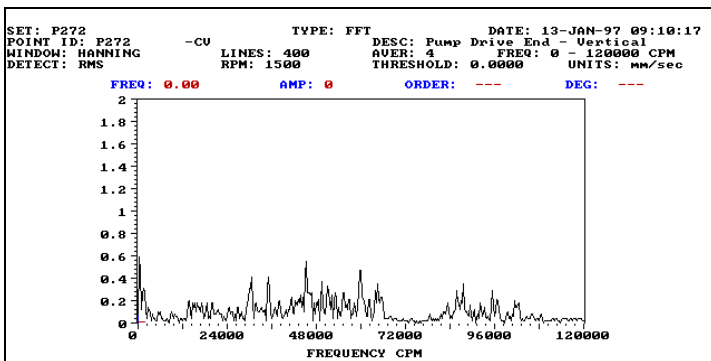
Vibration spectra collected from the pump drive end bearing on the 13th January 1997 did not exhibit any of the calculated fundamental defect frequencies for an SKF 6311C3 bearing, although the vibration spectrum did indicate baseline lifting between 24000 cpm and 72000 cpm indicating a 'noisy' bearing, see Figure 2 below.

Figure 2 - Early signs of bearing wear/damage.

Based on the overall vibration levels and the early signs of bearing defect in the spectrum it was decided to continue running the machine and review the next set of data. 35 days later the machine was re-tested and exhibited a further increase in overall vibration levels along with an increase in broad band activity in the vibration spectrum, see Figure 3. Based on this information it was planned to replace the pump bearings as soon as the production process allowed.

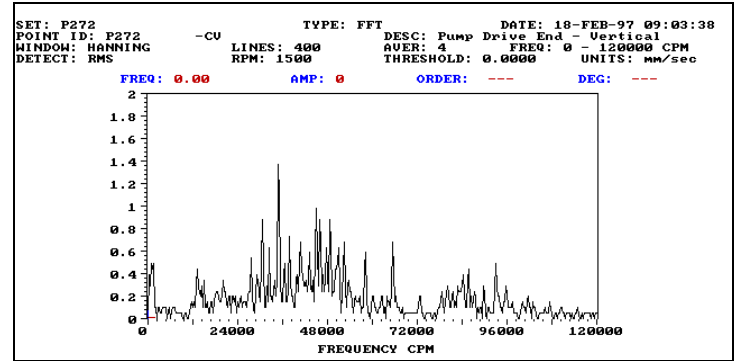
Figure 3 - Increased bearing wear/damage

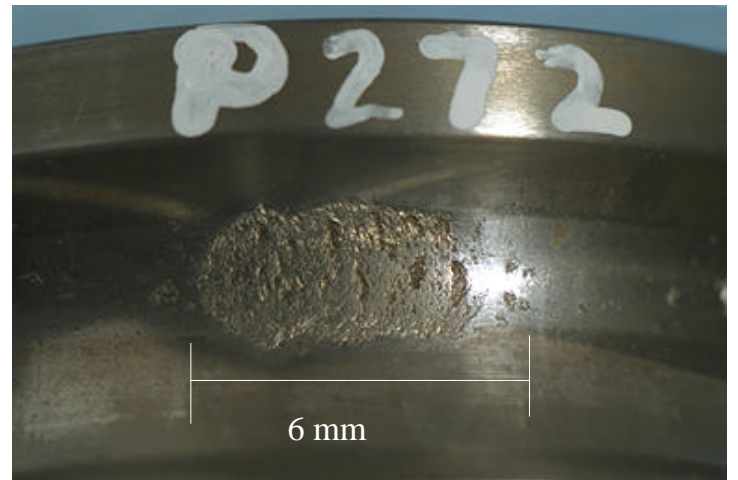
Examination of the pump bearings highlighted an area of flaking on the inner race of the ball bearing and subsequent damage of the outer race and several balls. Figure 4 below shows the damaged area on the ball bearing inner race.

Figure 4 - Spawling on the bearing inner race.

The bearings were replaced and the machine was brought back into service with minimum disturbance to the process. The parts and labour cost saving due to early fault detection was estimated to be **£4,000**.
