Case History No.3 BEARING OUTER RACE DEFECT

A request came into AVT's site office to carry out a vibration survey on P9917 (VIL) pump on the Shop PU, as there was a suspected fault with the electric motor.

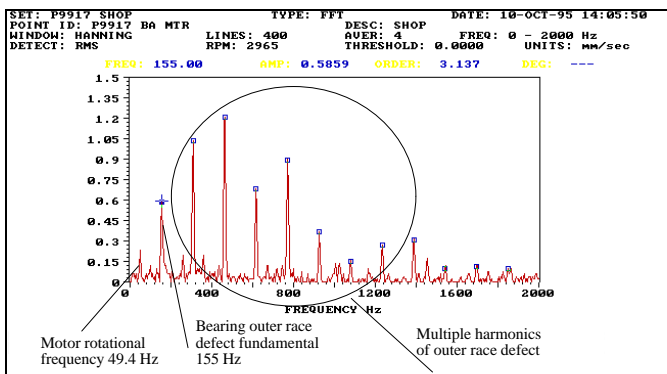
Figure 1 - Identification of spectral components.

Examination of the vibration spectrum indicated frequency components that would be attributable to bearing damage, with the highest overall reading recorded at the motor NDE bearing in the horizontal direction, however, the spectrum indicating the most informative signature was recorded in the axial direction.

Evident on this signature is a peak at 155 Hz, along with harmonic activity thereafter, see Figure 1 below.

This 155 Hz peak was attributed to a defect on the outer race of the motor NDE bearing, (ref SKF 6314-C3) and was determined by the following calculation :-

BPFO = 0.5 Nn (1-(d/D) COS β where :-

N = Motor speed divided by 60 = 49.4 (Hz)
n = Number of balls or rollers = 8
d = Ball/roller diameter (mm) = 24 mm
D = Pith diameter (mm) = 110 mm
β = Contact angle of ball to race = 0

$$\therefore 0.5 \times ((49.4 \times 8) \times (1 - (24/110))) \times \text{COS } \beta = \underline{\underline{154.5 \text{ Hz}}}$$

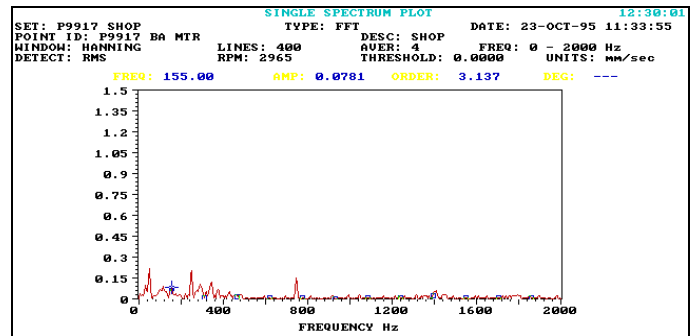
Figure 2 - Spectral activity recorded from the new bearing.

Figure 2 below shows the vibration spectrum taken from the same test point on the motor after bearing renewal.

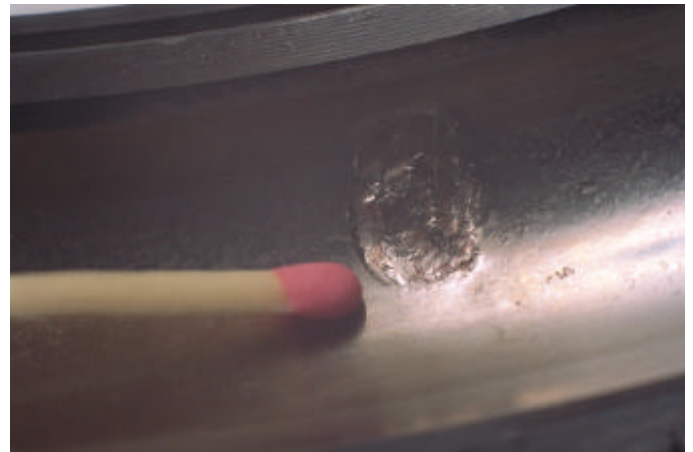
Figure 3 - Pictorial evidence of correct defect analysis.

Findings. On examination of the motor NDE bearing, an area of metal loss, (flaking), of approximately 6mm diameter was evident on the outer race of the bearing, see Figure 3 below.
