Case History No.4 LUBRICATION DEFICIENCY

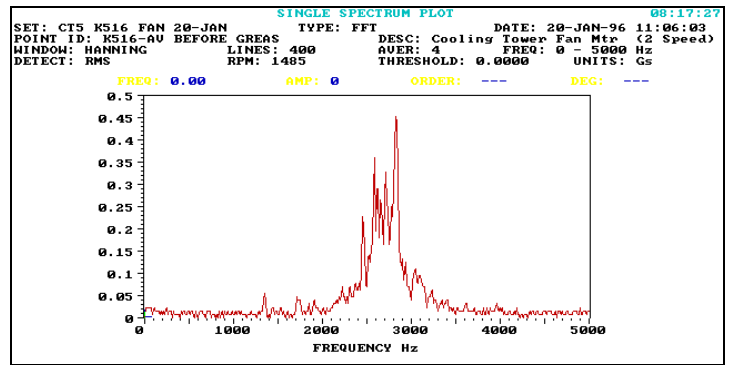
To determine the cause of this noise, a set of 5000Hz acceleration readings were obtained from both the NDE and DE motor bearings in the vertical, horizontal and axial directions. On examination of the spectra from both DE and NDE bearings in the vertical direction a 'haystack' effect was evident in the region of 2000 to 3500 Hz (see Figure 1).

This type of spectrum, based on experience, is normally generated by a reduction in the lubrication effect resulting in some degree of metal to metal contact within the rolling element bearing. If this condition is not remedied then accelerated bearing wear will occur leading to an increase in operating temperature and consequent bearing failure, see Figure 1.

Figure 1 - Before bearing lubrication.

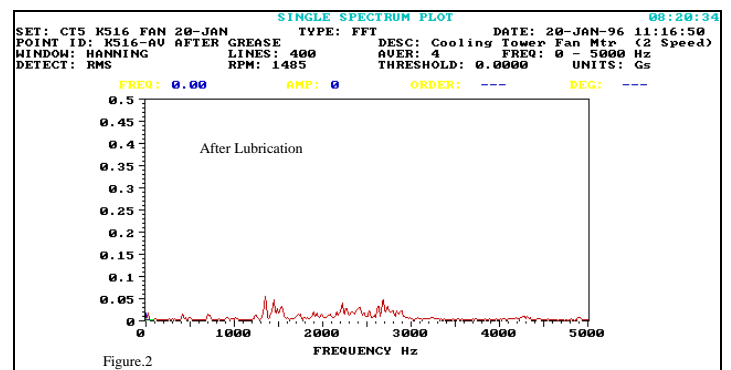
Figure 2 - Reduced high frequency vibration.

Once the condition had been determined, it was decided to apply a given amount of lubricating grease to this bearing. With the vibration data collector set to analyser we were able to monitor the immediate effect the lubricating grease had on the vibration. After grease was added and distributed within the bearing the live spectra indicated a slight recurrence of the original condition, it was then decided to apply a further few shots of grease. The effect was immediately noticeable with a considerable reduction in vibration activity exhibited by the analyser. The same procedure was carried out at the motor DE bearing, see Figure 2 below.

Conclusion - By locating and correcting this lubrication deficiency, a possible motor bearing failure due to this condition was prevented.
