Case History No.5 K9451 COUPLING IMBALANCE

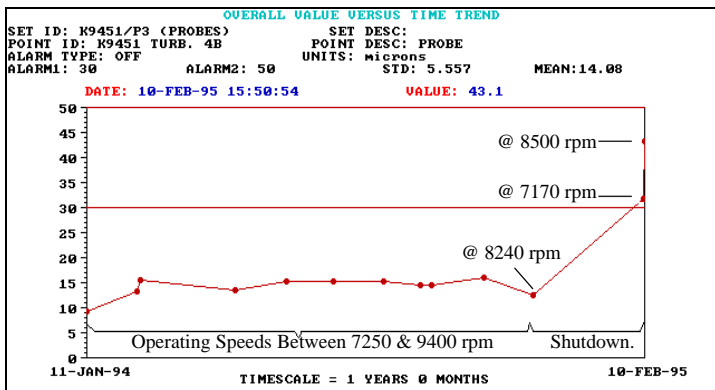
Historical data recorded on our on site database revealed that vibration levels prior to the process unit shut down were normal for all bearing cap readings and also the Bently Nevada displacement probe data. Bearing cap readings that day were typically below 2mm/sec rms and gave no cause for concern. However, during start-up with the machine running at 7170 rpm, the Bently Nevada probes indicated the highest overall shaft vibration relative to the bearings of about 32 microns. When the running speed was increased to 8500 rpm the highest overall shaft displacement increased to over 43 microns see Figure 1 below.

Figure 1 - Trend plot indicating overall vibration level changes.

Examination of the vibration spectrum exhibited a dominant component at the running speed frequency with an amplitude of 38 microns pk-pk indicating a probable imbalance condition of the turbine rotating element. Further questioning revealed that a new rotating element had been fitted to the turbine during the January 1995 shutdown, strongly suggesting the turbine as the source of vibration, as levels on the compressor exhibited little change from previous tests. To confirm this, the turbine was uncoupled from the compressor and run up to 7250 rpm with the coupling boss still in place. The running speed component was now less than 10 microns, clearly the turbine rotor itself was not at fault and attention switched to the coupling.

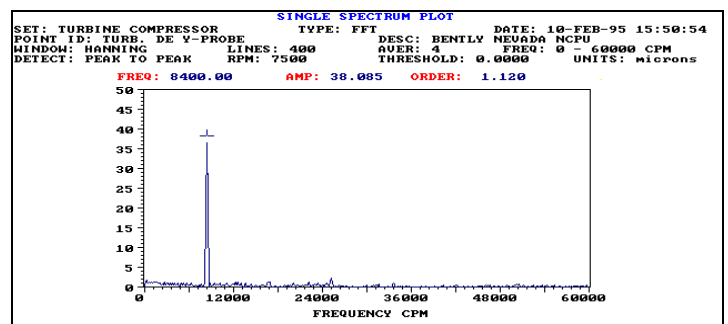
the coupling and its associated packing pieces/shims. During inspection of the coupling it was noticed that the spacers between the coupling bosses and the spool piece had been fitted in a different configuration to that prior to shutdown. The coupling was re-fitted according to all the match-marks and the coupled unit was run up to 9000 rpm. Highest reading of around 10 microns clearly indicated that the source of the imbalance had been correctly located and rectified. See Figures 2 and 3 below (before and after)

Figure 2 - Before coupling correction

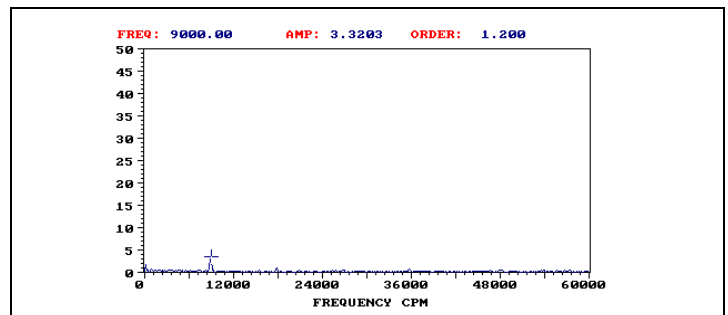
Figure 3 - After coupling correction.
