## Case History No.6 COOLING TOWER FAN BALANCE CORRECTION

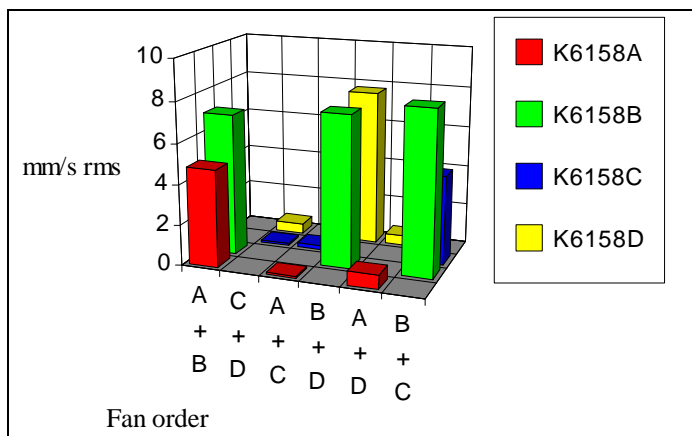
The results of these sequences can be seen in Figure 1 below.

<u>Fans</u>	<u>Amplitude (mm/s rms)</u>
A + B	4.8 + 7
C + D	0.1 + 0.5
A + C	0.1 + 0.2
B + D	7.5 + 7.7
A + D	0.7 + 0.5
B + C	8.1 + 4.4

Figure 1 - Results from the 2 fan sequence tests.

It was recommended that an in-situ balance be performed on the 'B' machine fan to reduce the vibration levels and allow continued operation of the cooling tower fans throughout the summer months ahead when demand on the tower would be high.

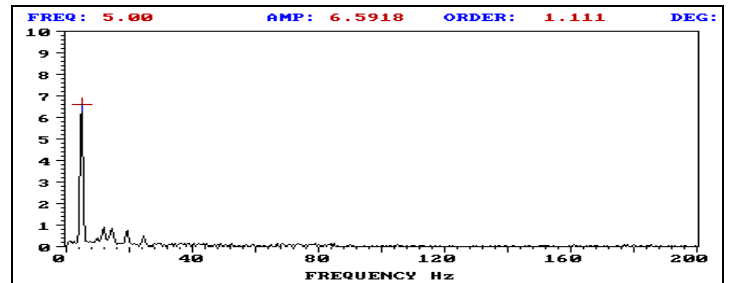
A phase reference optical sensor and accelerometer were fitted to the gearbox output shaft and cabled out to a safe location. During this operation it was noticed that a large steel block had at some time been fitted to the fan hub, also, the fan tip drain holes were found to be blocked, these were subsequently cleared. With this weight still in place the fan was brought on line and phase and vibration data collected. The results of this 1st run indicated a running speed peak of 6.6 mm/s rms. The fan was then isolated and the mass on the hub measured at 10kg. Inspection inside the stack revealed water around its circumference at blade tip height and it is assumed this came out of the fan blades as a result of clearing the drain holes. The fan was run up a second time without the mass and again the phase and amplitude measured. The amplitude of the fan rotational frequency peak had reduced to less than 0.5 mm/s rms, clearly the problem was the 10kg mass, no further action was needed as the imbalance had been located and corrected. Figures 2 and 3 below give the before and after condition.

Figure 2 - Before balance correction.

It is possible that this weight was used to balance out the effect of the water in the blades, although this is not conclusive.

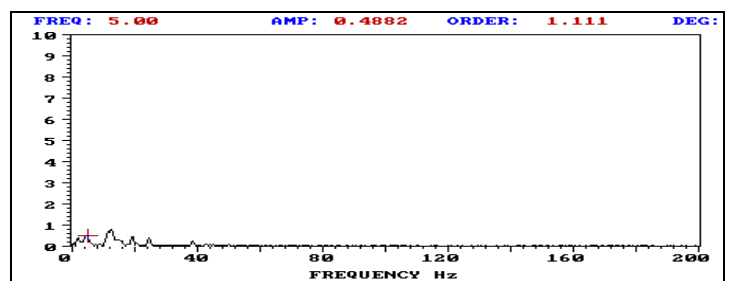
Figure 3 - After balance correction.
