Case History No.7 HIGH SPEED PUMP COUPLING IN-SITU BALANCE CORRECTION

P2152B is an electric motor driven boiler feed water pump coupled to a 2 shaft gearbox designed to increase the speed from 2970 rpm (input), up to 5400 rpm (output).

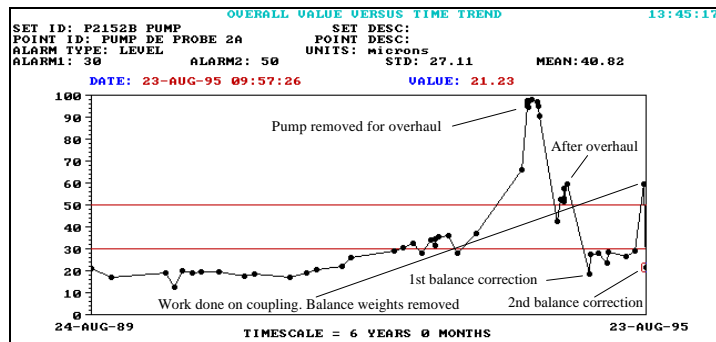
From December 92, and up to April 94 the displacement readings taken from the pump drive end bearing were becoming erratic, and had reached an overall level of 65 microns pk-pk, indicating a possible problem with the pump or coupling unit.

On examination of the spectrum it was clear to see that the predominant activity was that of the running speed component of 90Hz (5400 rpm).

In May 94 the overall vibration level had reached 95 microns pk-pk, the pump was removed from service and sent for overhaul and balance check/correction, see Figure 1 below.

Figure 1 - Overall displacement trends at pump drive end.

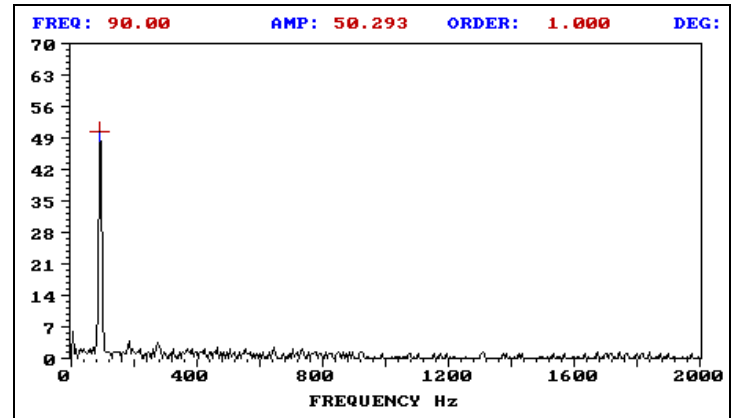
After a series of test runs, and with the addition of trail weights, we were able to calculate the correction weight and determine its angular position. From then on, the machine ran for some 7 months at levels below 30 microns, until such a time when the coupling was disturbed for maintenance purposes. After this work had been completed, vibration readings indicated that the initial imbalance had returned and thus the coupling was immediately suspect.

On examination of the coupling, it was noted that the original correction weights had not been replaced and therefore required the balance correction to be performed again. Figures 2 and 3 below testify the before and after results.

Figure 2 - Imbalance before correction (50 µm pk-pk).

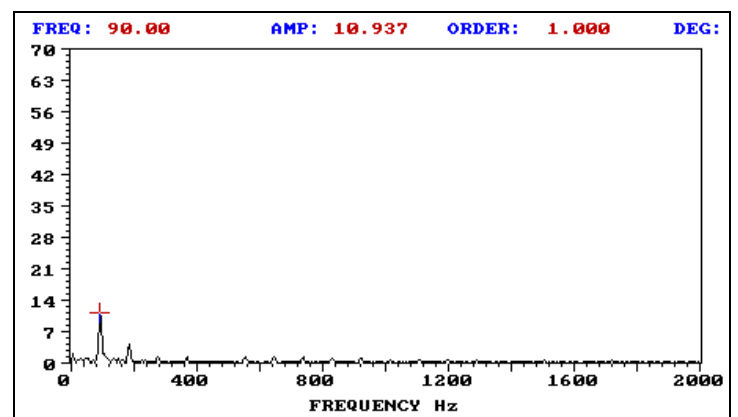
Figure 3 - Imbalance after correction (11µm pk-pk).

This in-situ balance allowed the machine to remain in service until such a time when operational and machine availability allowed machine removal for a full investigation of the problem.
