Case History No.8 VIBRATION ANALYSIS TO DETECT GEAR DAMAGE

The following case history shows how spectral analysis proved invaluable in helping identify a problem gear in a cooling tower fan gearbox.

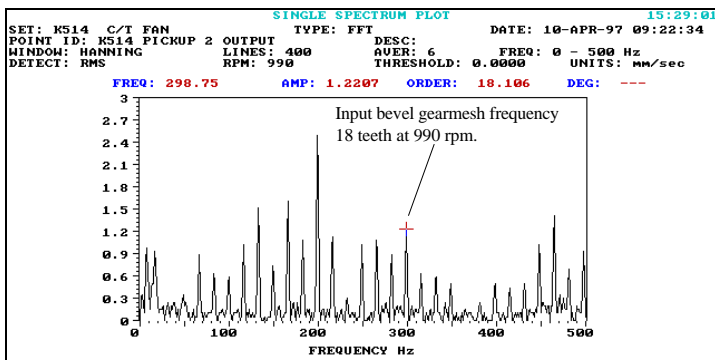
Figure 1 - Vibration spectrum indicating gear damage.

From the above spectrum, and knowing the fan was running at low speed, we could identify the input bevel gear meshing frequency. Harmonic activity at the input shaft frequency of 16.5 Hz are evident at either side of the input gearmesh frequency. From this information, and technical data from the gearbox (Figure 2) it was concluded that the input bevel gear had sustained some degree of gear tooth damage.

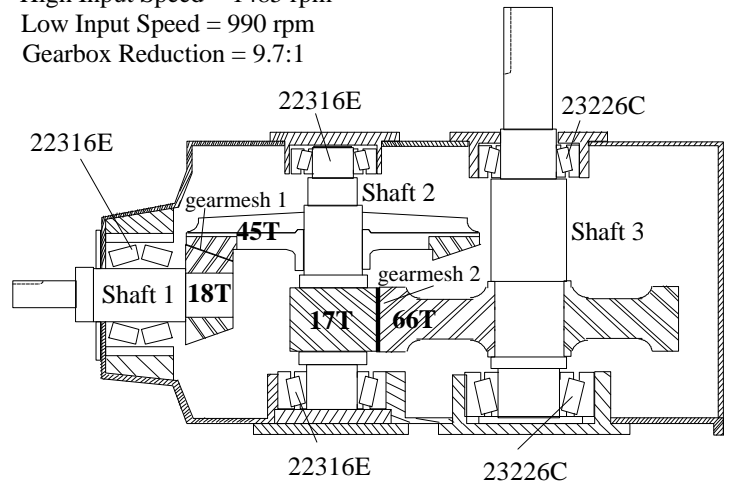
High Input Speed = 1485 rpm
Low Input Speed = 990 rpm
Gearbox Reduction = 9.7:1

Figure 2 - Layout of gearbox internals.

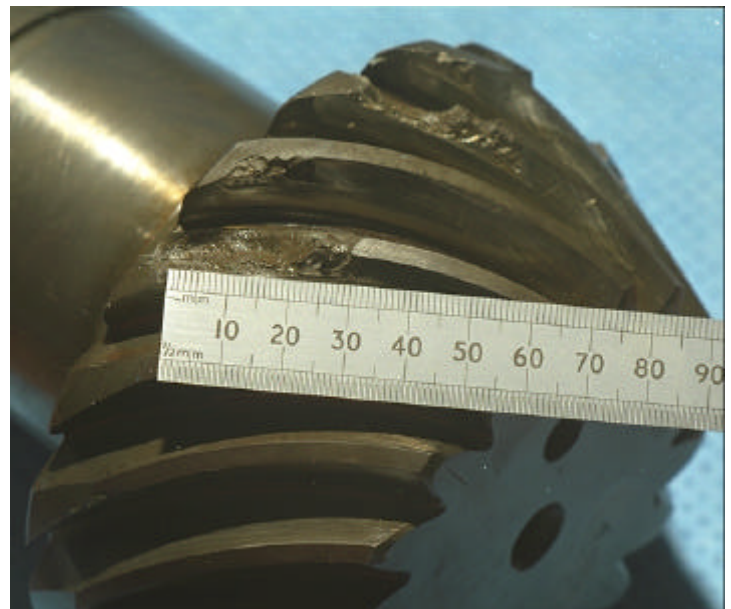
Examination of the gearbox proved the analysis to be accurate, with damage to several of the bevel gear teeth evident. Figure 3 below is photographic evidence of the damaged gear teeth.

Figure 3 - Damaged input bevel gear teeth.
