A V TECHNOLOGY LIMITED

Case History No.9 IN-SITU BALANCE OF A OVERHUNG FAN

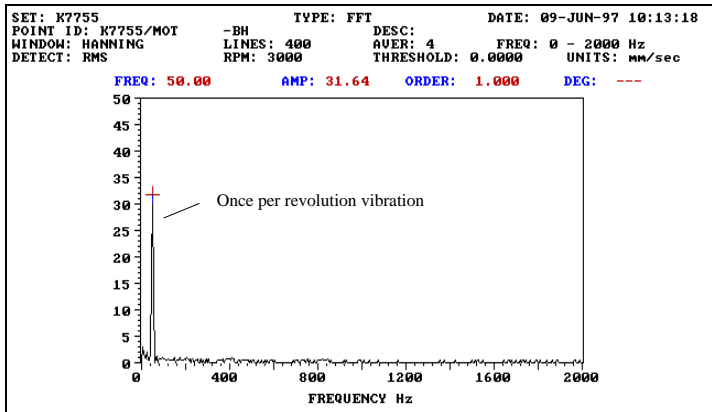
This case history shows how in-situ balance correction can be performed without the need of a costly machine outage. Vibration data collected from the motor of an overhung fan assembly indicated the worst recorded once per revolution vibration to be at the motor drive end horizontal direction with an amplitude of 30 mm/s rms as shown in Figure 1.

Figure 1 - High once per revolution vibration.

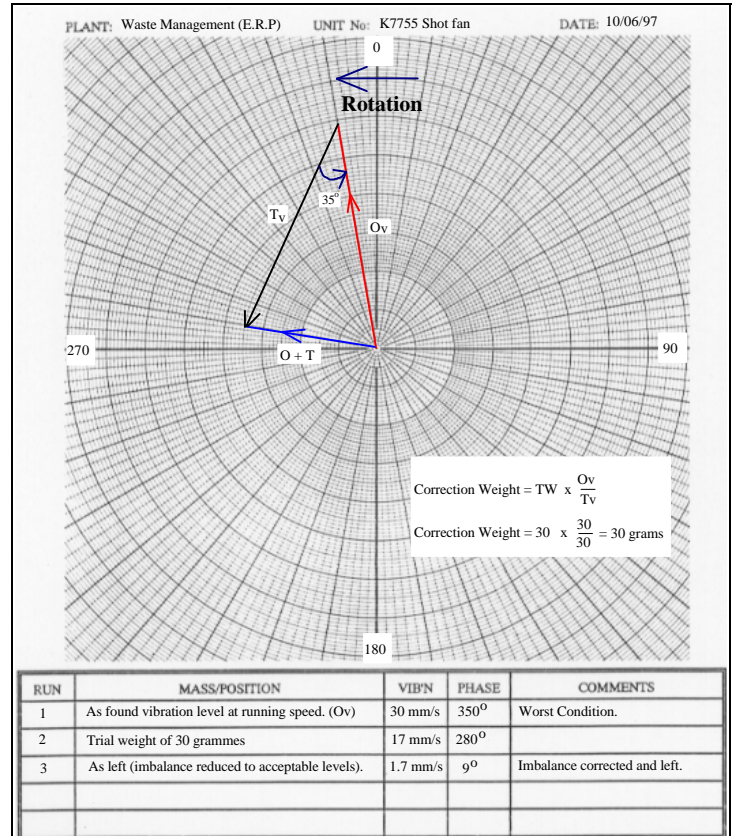
Figure 2 - Vector chart indicating vibration levels and phase.

The amplitude of the once per revolution vibration, along with its angular position from a known reference, was plotted on a vector chart as 'O_V'. The machine was brought to rest and a mass of 30 grams added to the outer radius of the fan at an arbitrary position. The machine was brought up to speed and the new amplitude and phase angle of the once per revolution vibration plotted on the vector chart as 'O+T'. From these two vectors we could determine the vector change caused by the trial weight, this was plotted on the vector chart as 'T_V'. From these values the mass of the correction weight was calculated and its angular position from the trial weight found, see Figure 2.

The correction weight required was 30 grams and would have to be positioned 35° from the trial weight position in the direction of the machines rotation. Once the correction weight was fitted, the trial weight was removed and the machine run up to full speed.

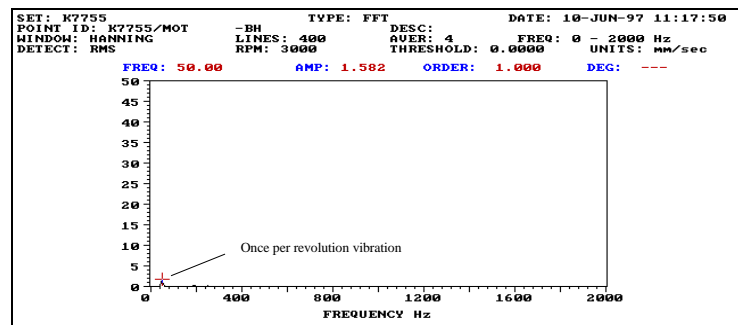
Vibration data recorded indicated that the source of the imbalance had been correctly located and corrected as depicted in Figure 3.

Figure 3 - Imbalance reduced to 1.6 mm/s rms
