Case History No.10 PUMP DIAGNOSIS (Overall v Spectrum)

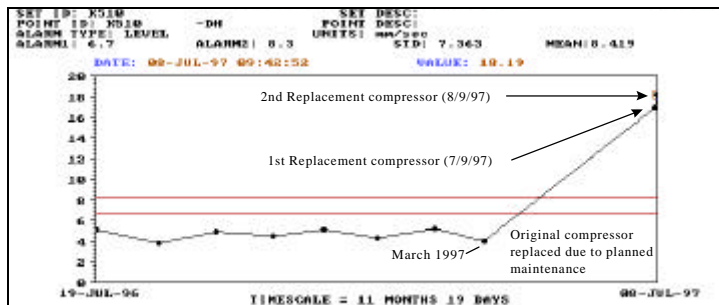
K510 is a liquid ring vacuum pump and is directly driven by a 18½kW, 1460 rpm motor. During April 1997 the compressor section of the machine was replaced due to planned maintenance scheduling. Baseline vibration levels recorded from the non drive end bearing of the new compressor were in the order of 18 mm/s rms, indicating an increase of 72% above the previous average levels and were clearly not acceptable see Figure 1.

Figure 1 - Compressor non-drive-end vibration levels.

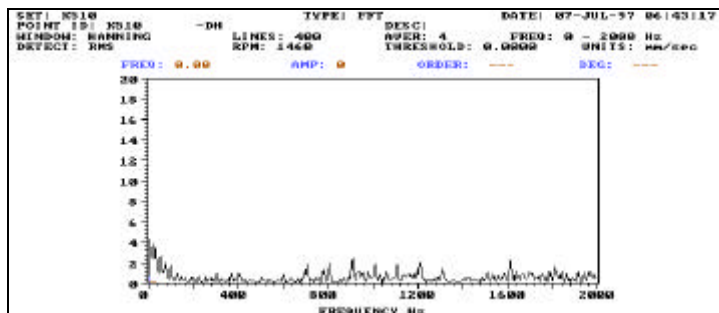
Investigation of the vibration spectrum indicated broadband activity up to 2 kHz suggesting a damaged bearing, see Figure 2. Based on this information a recommendation was made to replace the compressor bearings,

Figure 2 - Vibration spectrum indicating bearing damage.

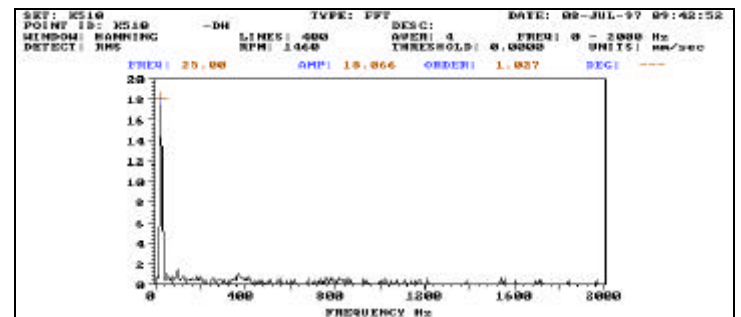
The compressor was removed and a 2nd replacement compressor fitted. On start-up of this machine (8th July 1997) the vibration levels at the compressor non drive end bearing were also in the order of 18 mm/s rms. On examination of its vibration spectrum, the dominant component was that of the rotational frequency indicating an imbalance condition see Figure 3.

Figure 3 - Vibration spectrum indicating imbalance condition.

This compressor was also removed for overall and balance correction. On examination of the bearings from the 1st machine it was evident that they had suffered water ingress during storage. The lubrication film between the bearing surfaces failed causing severe water etching (galvanic corrosion) of the rollers and bearing races. see Figure 4.

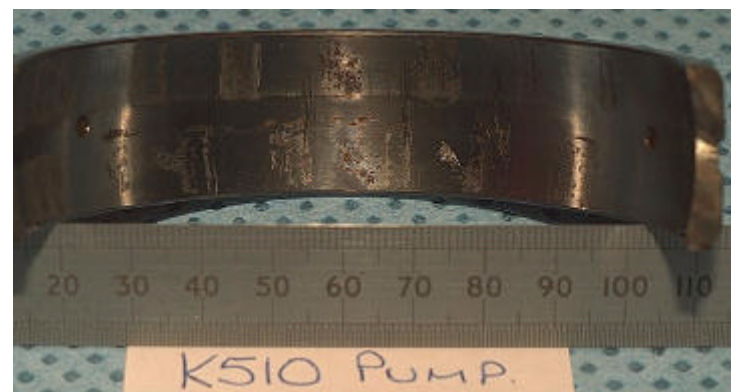
Figure 4 - Galvanic corrosion of the roller outer race.
