Case History No.11 MOTOR DRIVE END BEARING FAILURE

P9801A & P9801B pumping units are responsible for the circulation of Santotherm 66 (a heating medium typically at an operating temperature of 296°C). Both machines form part of the C.I.M.A.H regulation 1984 (Control of Industrial Major Accidents Hazards) and are critical to the SHOP PU manufacturing process.

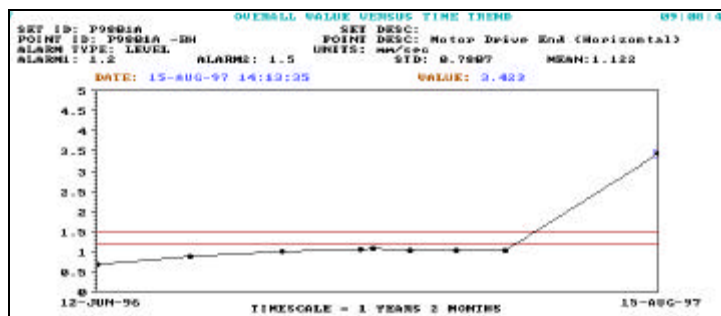
When the two machines were again service rotated some 4 months later a 'step change' in the overall vibration levels was observed at both the non drive end and drive end of the P9801A motor see Figure 1 below, the pump vibration levels remained unchanged. Vibration levels recorded at the motor drive end bearing were higher than the non drive end bearing thus indicating the source of the problem to be in this area, however the cause was not yet known.

Figure 1 - Step change in overall vibration.

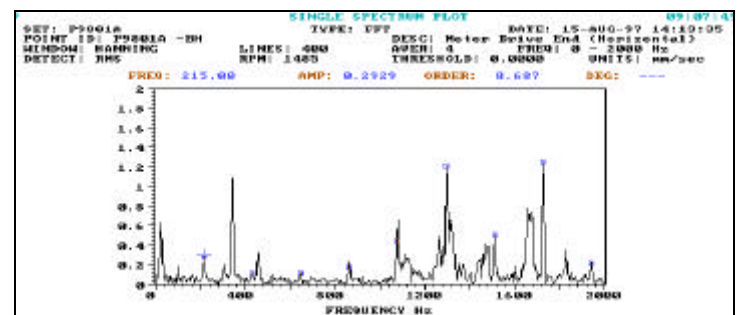
Analysis of the vibration spectrum indicated a large amount of spike energy along the 2kHz frequency range, from this information several fault types could be eliminated i.e. balance, alignment, coupling problems etc. The information in the

vibration spectrum initially pointed to a suspect drive end bearing, however, further analysis of the vibration spectrum would have to be carried out. Once the bearing fundamental defect frequencies had been determined I was able to link some of these frequency values to the frequency peaks evident in the vibration spectrum. In doing so, I identified a fundamental defect frequency of 215Hz strongly suggesting a fault on the outer race/roller of the single row roller bearing at the motor drive end, see Figure 2 below.

Figure 2 - Vibration spectrum indicating a bearing problem.

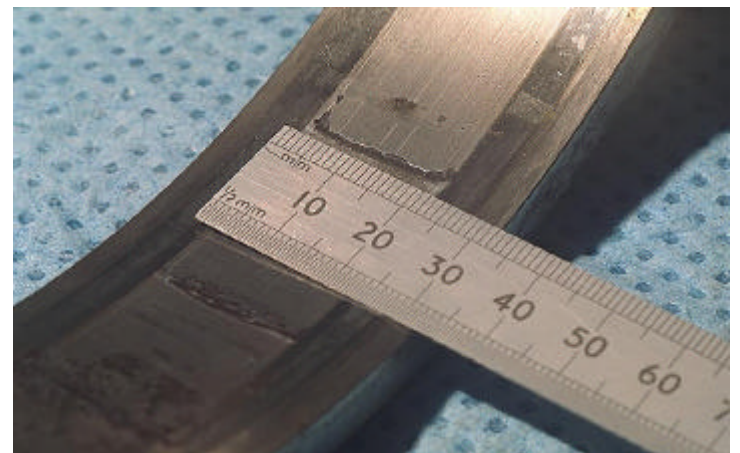
Examination of the original bearings proved the analysis to be correct as several areas of damage were evident on the roller bearing outer race, and also on the rollers themselves. The photograph below is clear evidence of this damage.

Figure 3 - Damage to roller bearing outer race.
