Case History No.12
MOTOR DRIVE PULLEY STEADY BEARING FAILURE

K4420-3 is a two stage in-line reciprocating compressor which is driven by a two speed (960/400 rpm) Laurence Scott electric motor via a 9 belt pulley system giving a compressor speed of either 345 rpm or 144 rpm respectively.

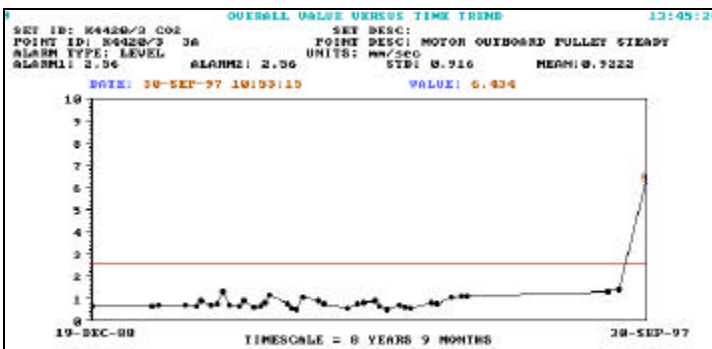
Historically, the overall vibration levels throughout the machine had been consistently low (around 1.4 mm/s rms) and had never given any cause for concern, however, the overall vibration levels recorded on the 30th September 1997 at the motor drive pulley outboard steady bearing exhibited a marked increase in the axial direction (position 3A), see Figure 2 below.

Figure 2 - Motor outboard pulley steady bearing.

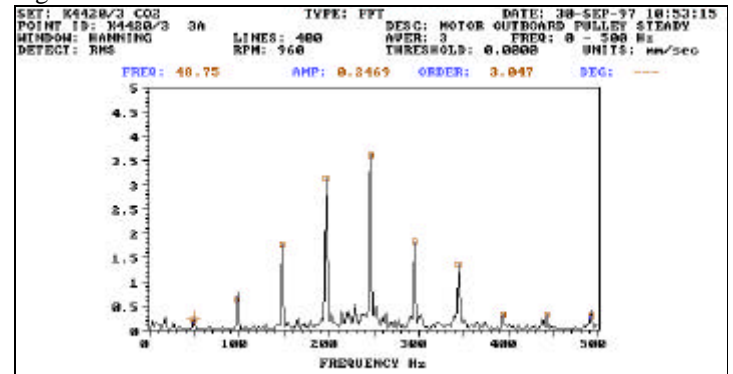
Examination of the vibration spectrum collected from this location exhibited several harmonic peaks across the 500 Hz

bandwidth indicating a possible bearing defect at this location, see Figure 3.

Figure 3 - Vibration spectrum indicating suspected bearing damage.

The site Mechanical Engineer was immediately made aware of the change in the vibration levels with a recommendation to replace the bearing as soon as possible.

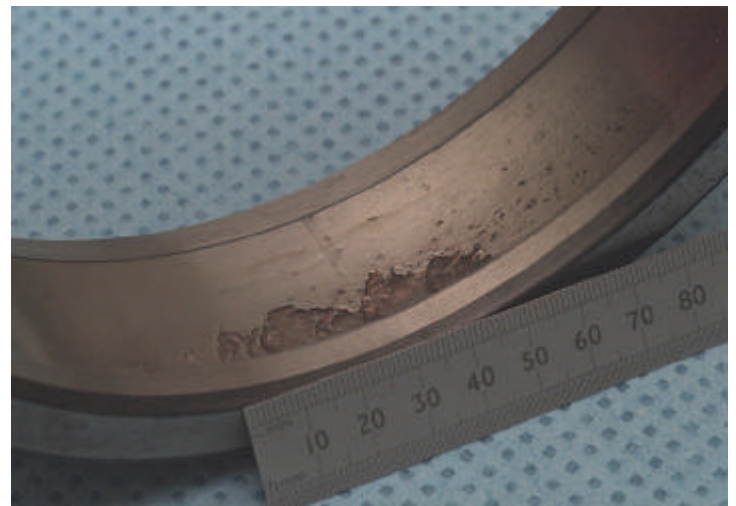
The machine was subsequently taken off line and the bearing replaced. On examination of the original bearing, a large area of flaking (spalling) was evident on the outer race, see Figure 4.

Figure 4 - Photograph showing bearing outer race damage.
