Case History No.13 K6321 MOTOR NON DRIVE END BEARING FAILURE

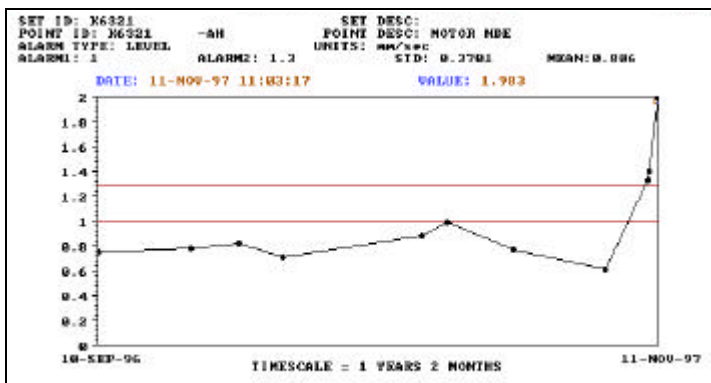
Based on the fact that the overall levels were still considered low, and being aware of this increase it was decided to continue to run the machine and re-test the motor in 5 days time during which, provisional plans to remove the motor could be made. On the 11th November 1997 a further set of readings were taken, and again an increase in overall levels was evident see Figure 1.

Figure 1 - Continued increase in overall vibration levels.

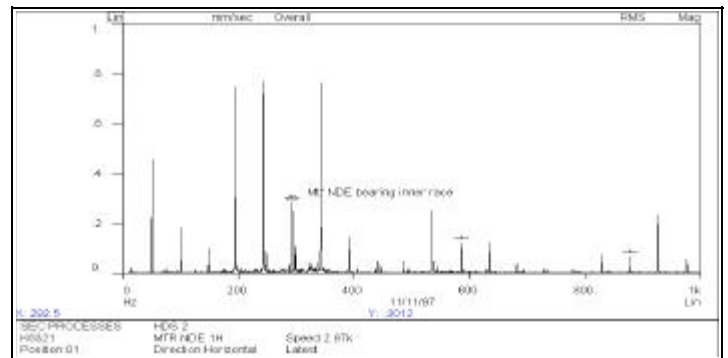
Examination of the vibration spectrum exhibited a peak at 292.5 Hz and tied in to the calculated defect frequency for the motor non drive end bearing inner race see Figure 2.

Figure 2 - High resolution spectrum indicating bearing damage.

Based on this information, a recommendation to remove the machine was made. As this machine was not spared, the production unit had to shut down. The motor was removed and

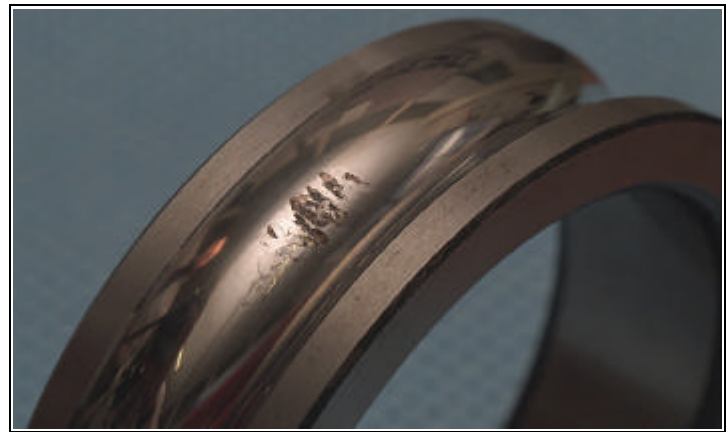
sent away for bearing renewal, the old bearings were returned to site and an inspection into their condition carried out. The drive end bearing was found to be in good condition with a plentiful supply of lubricating grease evident. The non drive end bearing however, had as predicted from the vibration spectral analysis, a fatigued area of 10mm by 8mm on the inner race see Figure 3.

Figure 3 - Photographic evidence of bearing inner race defect.
