Case History No.14 K3851A CENTRIFUGAL COMPRESSOR STAGE IMBALANCE

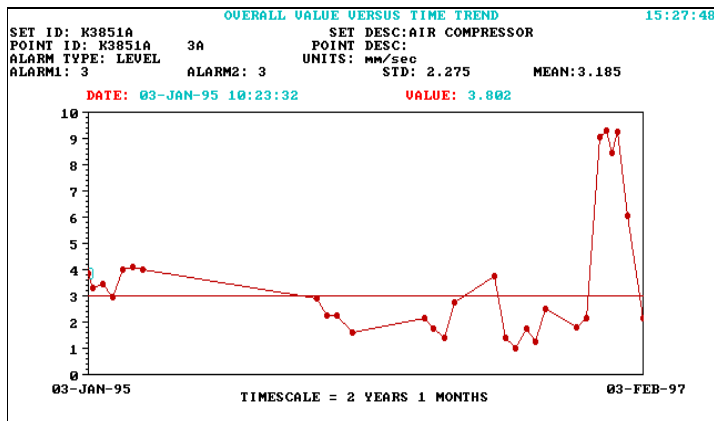
The trend plot shown in Figure 1 shows a step change at the bull gear drive end during the vibration survey conducted on December 6th 1996. The overall value of 9.0 mm/s was the highest value that had ever been recorded.

The machine was due to be serviced in approximately three months but the plant maintenance team decided to bring the service forward. The service report found that there was a build up of dirt and corrosion on the impeller vanes. The deposits were also found on the diffuser intake ring. There was also evidence that the impeller had been in light contact with the intake ring but there was no obvious damage to the second stage impeller. All the findings of the initial inspection are contributory to the step change in the overall value shown in Figure 1.

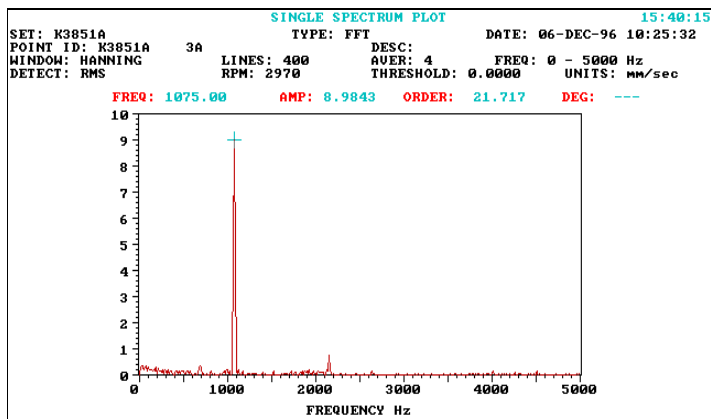
The spectrum plot shown below in Figure 2 was examined and it revealed a dominant peak at 1075 Hz was the major cause of the step change seen in the trend plot as shown in Figure 1.

The spectrum plot shown in Figure 2 also indicates that an imbalance as the probable cause of the problem. The machine operating handbook was consulted and it was found that the running speed of the second stage was 64515 rpm which equates to a frequency of 1075 Hz.

This indicated that there was an imbalance in the second stage. The plant maintenance team were informed via the action note system and it was recommended that the second stage impeller assembly was checked for signs of a build up of debris and for signs of damage which would cause an imbalance.

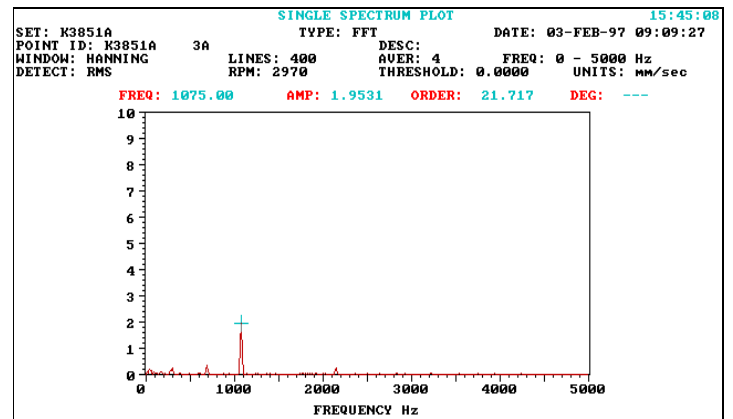
As can be seen the spectrum plot shown as Figure 3 taken after the service, the running speed component had reduced to an acceptable level of 1.8mm/s from the initial value of 9.0mm/s.
