Case History No.15
COOLING TOWER WATER PUMP BEARING FAILURE

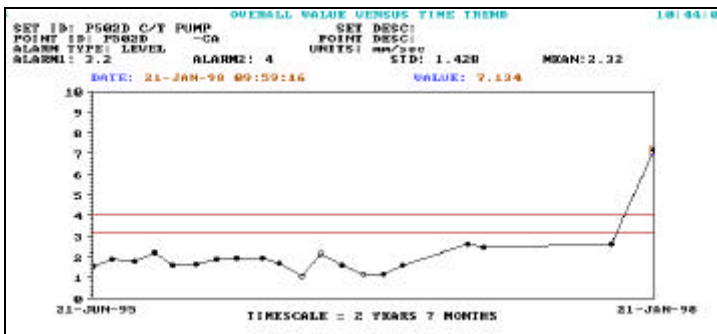
This particular pump had been out of service for inspection purposes and had not been tested for several weeks. During the routine vibration survey on the 21st January 1998 it was noticed that the overall vibration levels recorded at the pump drive end had exhibited a marked increase see, Figure 1.

Figure 1 - Pump drive end bearing trend

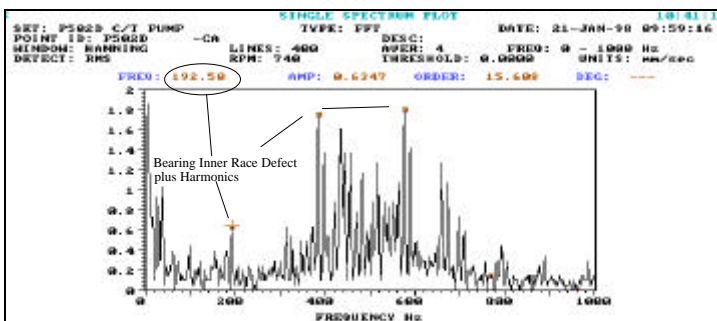
Examination of the vibration spectrum exhibited frequency components which matched the calculated defect frequencies for an RHP 318 C3 roller bearing with a inner race speed of 740 rpm, this defect frequency was calculated to be 192.5 Hz see Figure 2.

Figure 2 - Vibration spectrum indicating bearing inner race defect.

On further examination of this vibration spectrum, not only were the bearing inner race defect frequency components evident, but

also across the frequency bandwidth was a large degree of sub synchronous vibration, possibly caused by the rolling elements passing over the tiny particles of metal from the original fault that had been impregnated into the surface of the inner and outer races. A recommendation was made to replace the pump bearing and pass it to our office for inspection. Figure 3 below is photographic evidence of this inspection and indicates a crack all the way across and through the inner race leaving one part protruding slightly higher than the other. This slight protrusion would undoubtedly be the mechanism for generating the inner race spectral frequency component as the rolling elements passed over it.

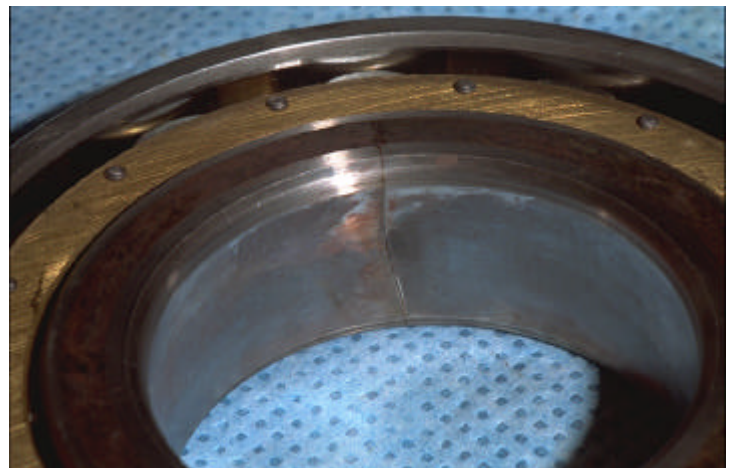
Figure 3 - Photograph showing crack through the inner race.

Further examination of the rollers and bearing races indicated surface irregularities in the form of indentations caused by tiny fragments of bearing material being forced into the raceways by the action of the rolling elements passing over them and it is these irregularities which would be responsible for the sub-synchronous vibration which was observed in the spectrum.

Fortunately the bearing inner race did not spin on the pump shaft and therefore secondary damage was minimised allowing bearing replacement to be carried out in situ.

The pump was subsequently brought back into service with minimal disruption to the process, baseline vibration recorded at the pump bearings indicated levels had returned to previous values. The estimated mechanical cost saving for this machine was in the region of **£12,000**.
