Case History No.17 Off-Shore Gas Platform HVAC Pressurisation Fan Bearing Damage.

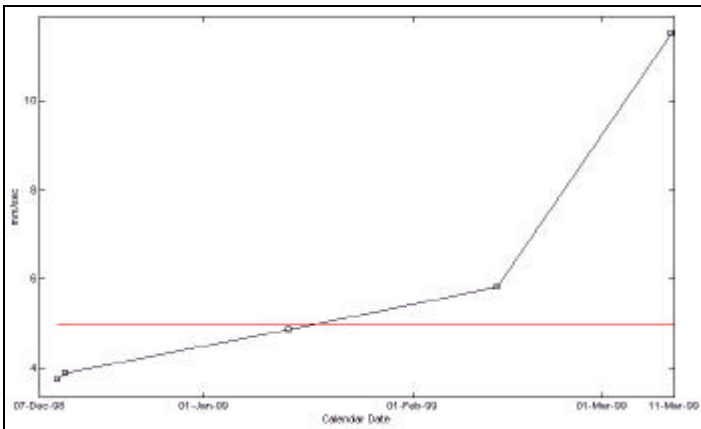
Since the application of CM activities on this twinned unit it was identified at an early stage that some underlying bearing defect was evident on one of the fan shaft support bearings on the North facing fan unit. This was demonstrated with a continuing rise in trended overall vibration levels recorded at the fan bearings, see Figure 1 below.

Figure 1 – Continued increase in overall vibration at fan bearing

It was recommended that the fan bearings should be changed at the earliest convenience to prevent catastrophic failure of the fan unit along with any subsequent secondary damage.

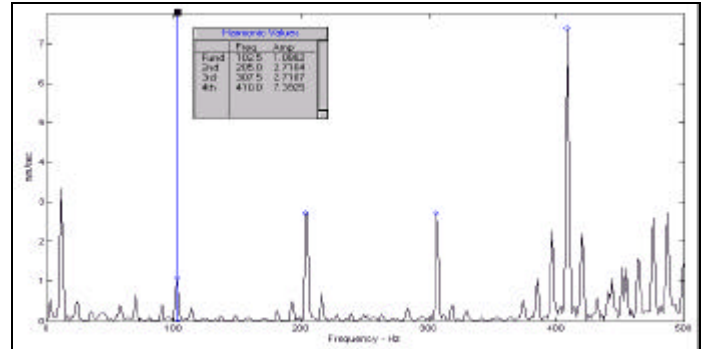
Examination of the vibration spectrum related to each overall value exhibited spectral activity and harmonic content which coincided with the calculated bearing defect of the bearing outer race (ball pass frequency outer BPFO) indicating some degree of damage to the bearings outer track. Each subsequent survey indicated an increase in this activity see Figure 2 relating to the latest trend reading.

Figure 2 – Vibration spectrum indicating bearing damage.

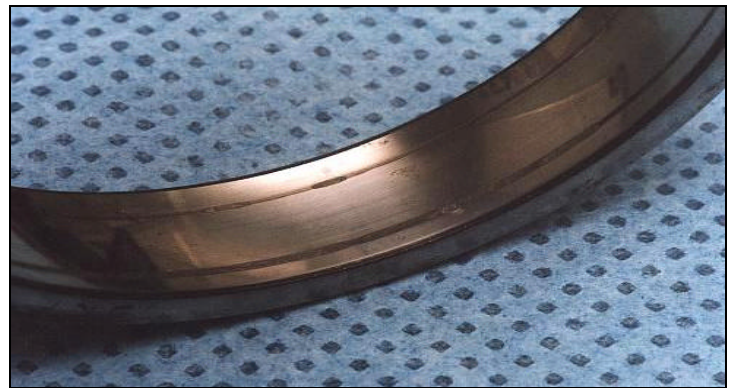
Examination of the old fan bearing concluded the analysis to be correct, with metal loss evident on the outer track due to wear/fatigue spawling see Figure 3 below.

Figure 3 - Photographic evidence of bearing damage.
