Case History

BEARING FAILURE DETECTION ON TOP WIRE GUIDE ROLL 3 DRIVE SIDE

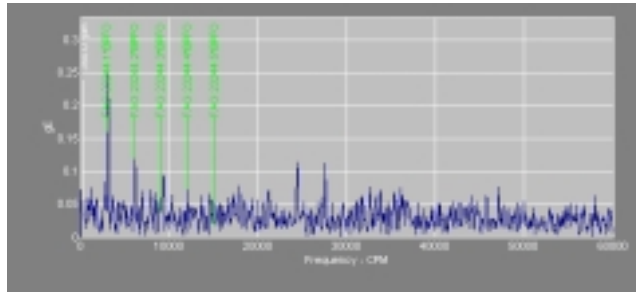
Reference vibration measurement on the drive side bearing of a 350 RPM, 111 mm diameter wire guide roll pointed out a severe BPFO and BSF bearing damage with impact visible in the acceleration enveloping spectrum (see Figure 1 and Figure 2)

Figure 1 – Spectrum of acceleration Envelope measurement indicating outer race defect.

As per recommendation, the roll bearings were replaced on July 17, 2003. To confirm that a defect actually existed, the drive side bearing was cut open and visually inspected (see Figure 4 and Figure 5)

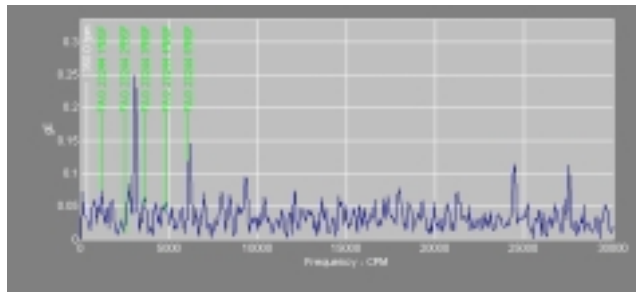
Figure 2 – Spectrum of acceleration Envelope measurement indicating roller defect.

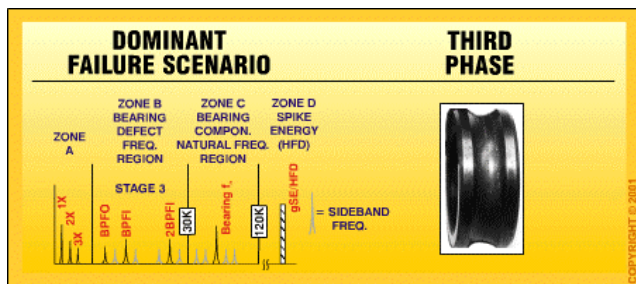
Having so many multiples of BPFI and number of sidebands grows, this spectrum fits the description of a stage 3 bearing failure as described in the Technical Associates Illustrated Vibration Diagnostic (Figure 3).

Figure 3: Stage 3 bearing failure

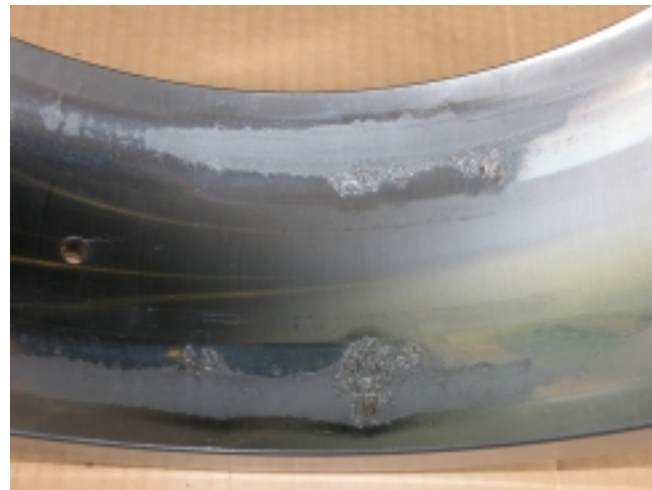
Figure 4 – Outer race defect found at drive side bearing.

If left uncorrected, a catastrophic failure could have occurred resulting in damage to the roll, top wire and other component to this roll.

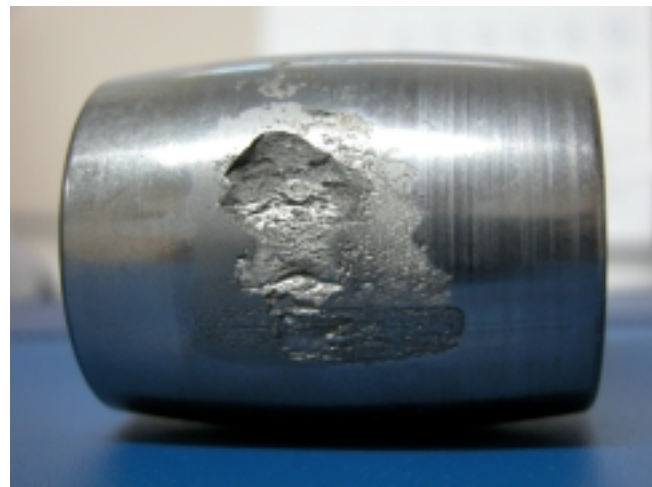
Figure 5 – Spherical roller damage found at drive side bearing
