BEARING FAILURE DETECTION IN FRONT SIDE OF FELT ROLL 47 (10TH DRYER GROUP)

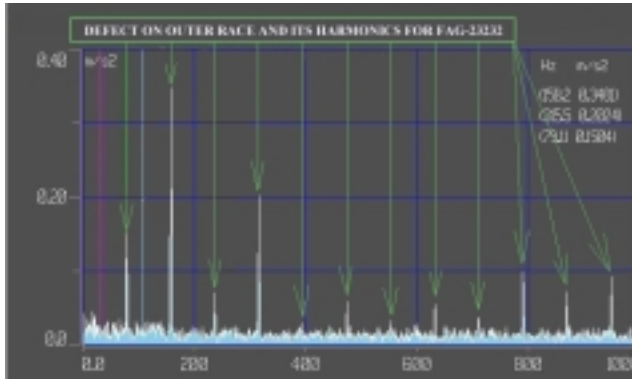
Reference vibration measurement on the front side bearing of a 625 RPM, 65 mm diameter fabric roll pointed out a severe BPFO bearing damage with impact visible in the acceleration-enveloping spectrum (see Figure 1).

Figure 1 – Spectrum of acceleration Envelope measurement indicating outer race defect.

As per recommendation, the roll bearings were replaced on February 12, 2004.

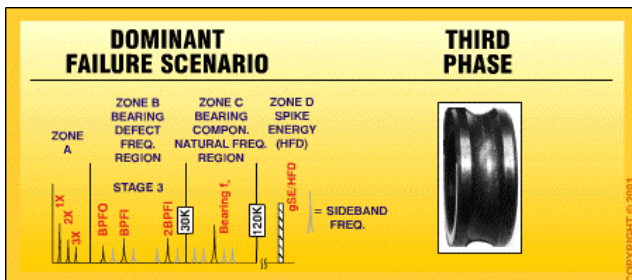
Having so many multiples of BPFO, this spectrum fits the description of a stage 3 bearing failure as described in the Technical Associates Illustrated Vibration Diagnostic (Figure 2).

Figure 2: Stage 3 bearing failure

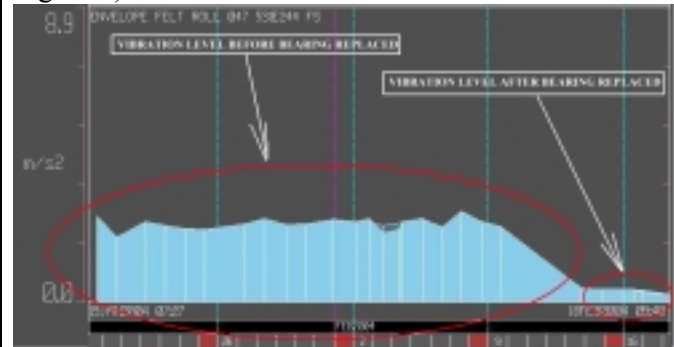
After replacement of roll bearings, a significant drop in vibration level can be seen in Figure 3. A figure 4 is waterfall picture of envelope spectrum and clearly shows that bearing defect frequencies disappeared after bearing replaced.

Figure 3: Vibration level before and after bearing replaced

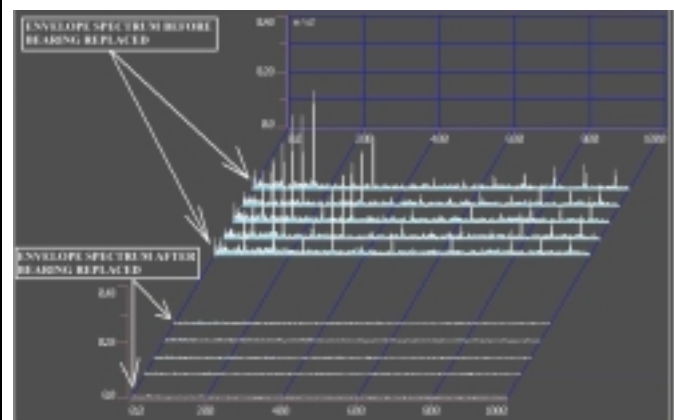
Figure 4: Waterfall picture showing improvement to the machine operation after bearing replaced

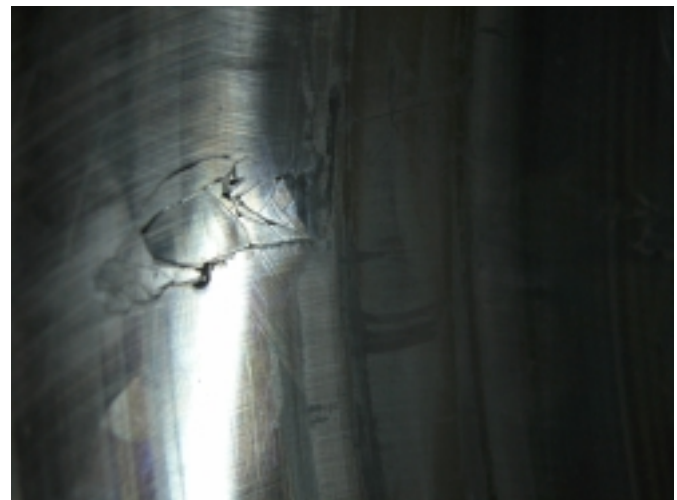
To confirm that a defect actually existed, the front side bearing was cut open and visually inspected (see Figure 5).

Figure 5 – Outer race damage found at front side bearing
