## 1<sup>ST</sup> DRYER GROUP INTERMEDIATE SHAFT DRIVE – CAGE DEFECT DETECTION

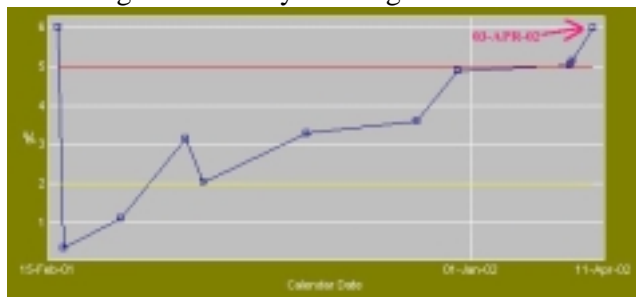
Vibration data collected from 1<sup>st</sup> Dryer Group intermediate shaft on February 2001 exhibited low and acceptable values, around 0.2 gE peak to peak. The bearing just replaced due to inner race defect. Next measurement the overall vibration level is increasing continuously. See Figure 1.

Figure 1 - Continued increase of overall vibration levels inboard bearing.

Based on the overall vibration levels and the signs of bearing defect in the spectrum it was planned to replace the 1<sup>st</sup> dryer group intermediate shaft bearings as soon as the production process allowed.

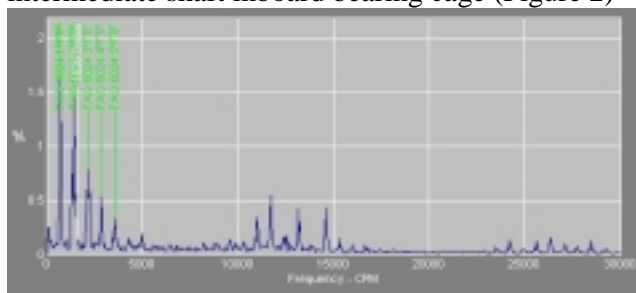
Examination of the vibration spectrum exhibited a peak at 712.5 CPM, along with harmonic activity and tied in to the calculated defect frequency for the intermediate shaft inboard bearing cage (Figure 2)

Figure 2 - Vibration spectrum indicating cage defect

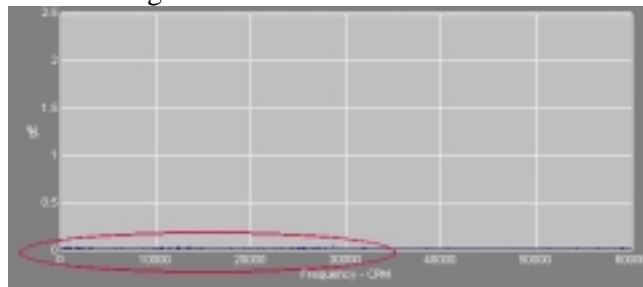
On 18<sup>th</sup> April 02 shutdown the bearing removed. Figure 3 below shows the vibration spectrum taken from the same test point on the intermediate shaft after bearing renewal.

Figure 3 - Spectral activity recorded from the new bearing

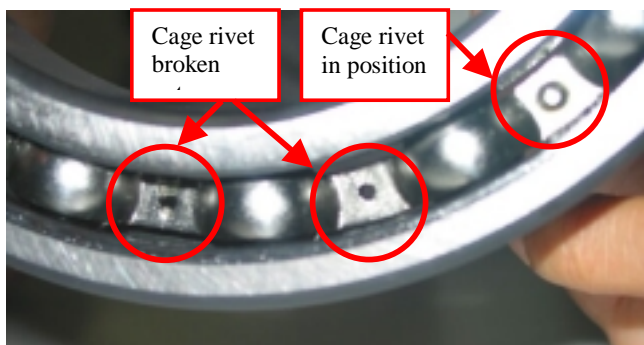
Examination of the original bearings proved the analysis to be correct as several cage rivet broken out. The photograph below is clear evidence of this damage.

Figure 4 - Pictorial evidence of correct defect analysis.

The intermediate shaft was subsequently brought back into service with no disruption to the process, baseline vibration recorded at the intermediate shaft bearings indicated levels had returned to previous values.
