Location : PM1 Wire Section
Position : Top Wire Forming Roll
Problem : Outer race and roller defect in back side bearing

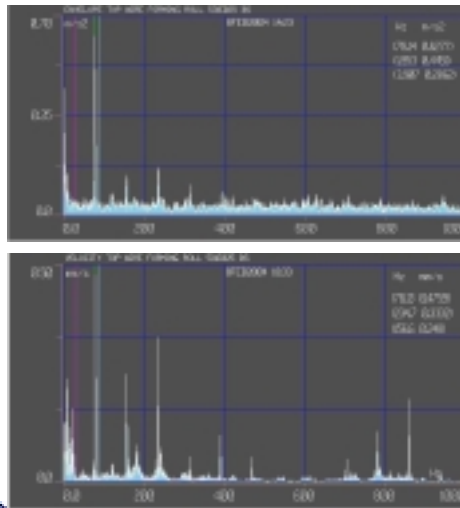
ENVELOPE AND VELOCITY SPECTRUM BEFORE BEARING REPLACED

Symptoms : During shutdown on 24 September 2003 the forming roll was replaced due to planned maintenance scheduling. Baseline vibration levels recorded from the back side bearing of the new forming roll was increase above the previous average levels and were clearly not acceptable. During that time there was no specific bearing frequency generated. After few days outer race defect frequency (BPFO) start to appeared and have harmonics as well as sidebands around. Since Nov 5, 2003 the BPFO peak just disappeared and new peak which is damage cage frequency appeared. Using BVM Detailed Analysis tool from Sensodec Advisor which was setup to 10,000 Hz meas. frequency, 1000 Hz low pass with 131072 points, the envelope spectrum then shows the frequencies that caused vibration in the selected resonance range (outer race defect frequency clearly seen to this spectrum).

Corrective Action : It had been decided to remove the roll from machine during annual shutdown on February 10, 2004. Examination of the backside bearing highlighted some areas of damage on the outer race of the bearing and subsequent damage of several rollers.

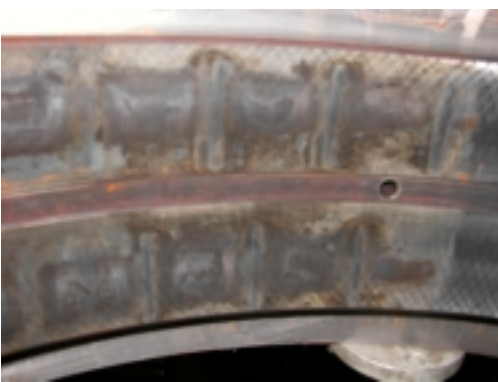
Examination of the original bearing highlighted some areas of damage on the outer race and roller bearing. The photographs are clear evidence of this damage. Further examination also found that the outer race had rotated on the bearing housing.
