Case History No.12
MOTOR DRIVE PULLEY STEADY BEARING FAILURE

K4420-3 is a two stage in-line reciprocating compressor which is driven by a two speed (960/400 rpm) Laurence Scott electric motor via a 9 belt pulley system giving a compressor speed of either 345 rpm or 144 rpm respectively.

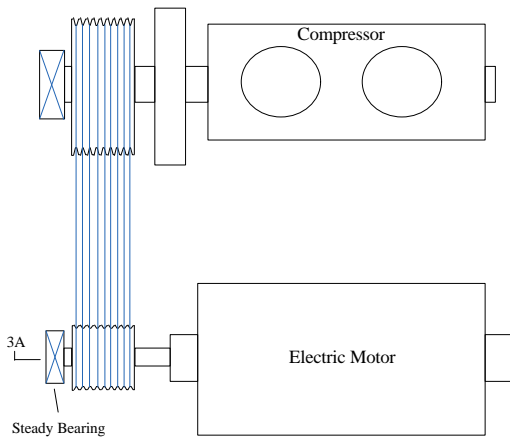
Figure 1 - Two stage reciprocating compressor.

This machine forms part of a monthly vibration monitoring schedule and is one of a team of three identical units that produce CO₂ for the chlorine liquefaction process, Figure 1 below shows the layout of the machine.
